Car Visor Clip

Natasha Hatcher, Art/Egt 396
Repair Project

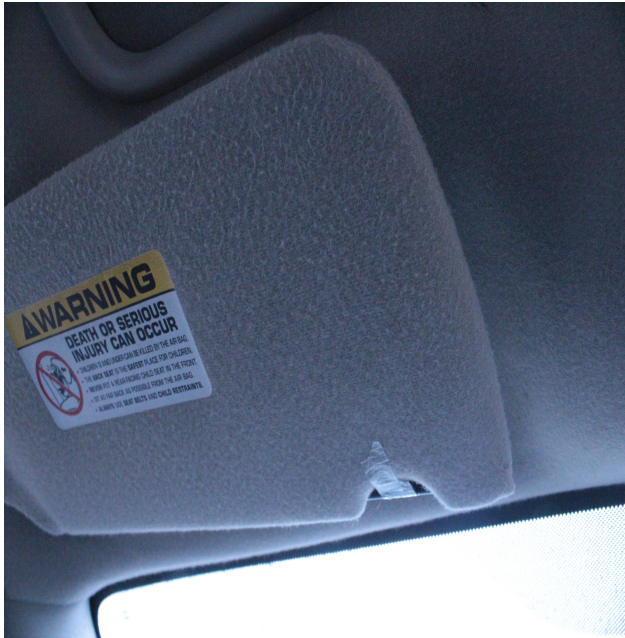
Visor with broken clip,
which happens to be on the
driver's side of the car. Not
good.

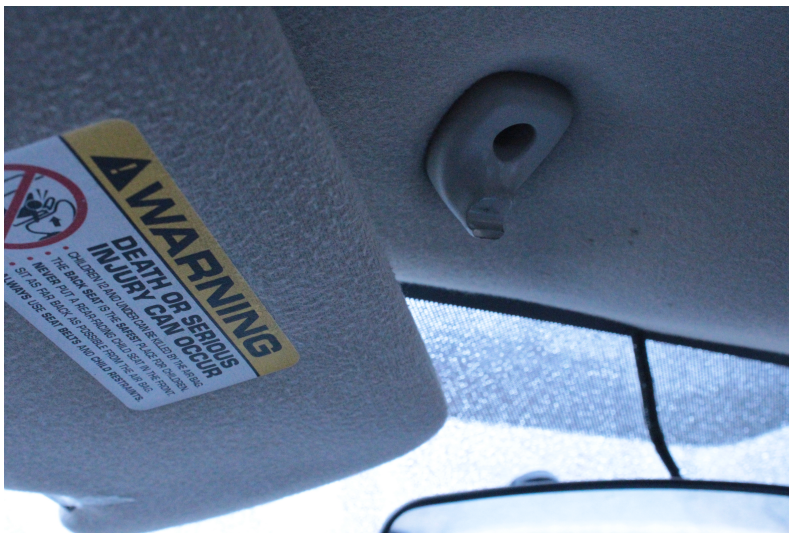
Not a good thing to have a visor
moving about when you are driving

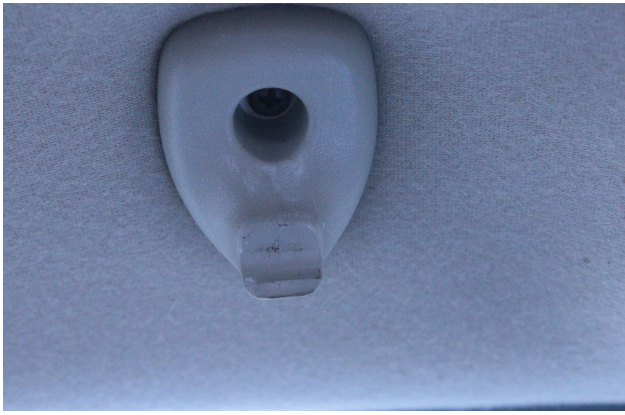
Head on view of broken clip

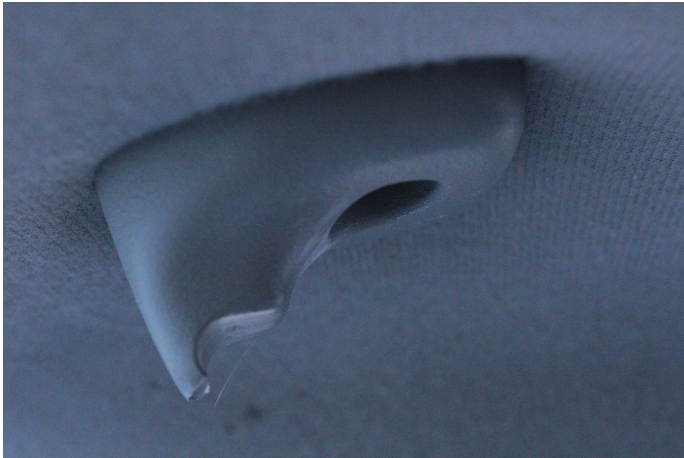
Side view of broken clip

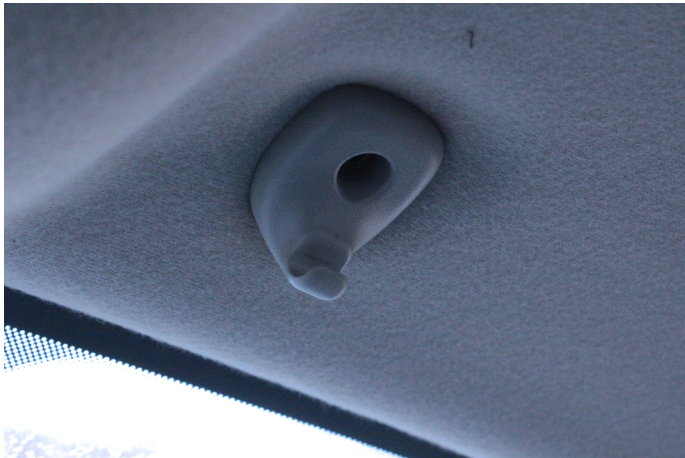
What the clip looked like before it was broken

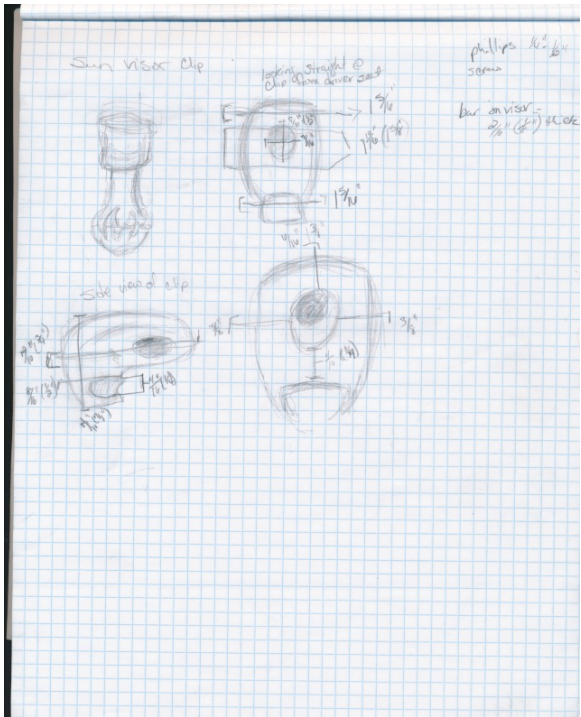
Measurements
